REHABILITATION OF EARTHQUAKE-DAMAGED AND SEISMIC-DEFICIENT STRUCTURES USING FIBRE-REINFORCED POLYMER (FRP) TECHNOLOGY

Ong Wee Keong

Fyfe Asia Pte Ltd, Singapore
10 Toh Guan Road #03-10 TT International Tradepark Singapore 608838
fyfeasia@singnet.com.sg

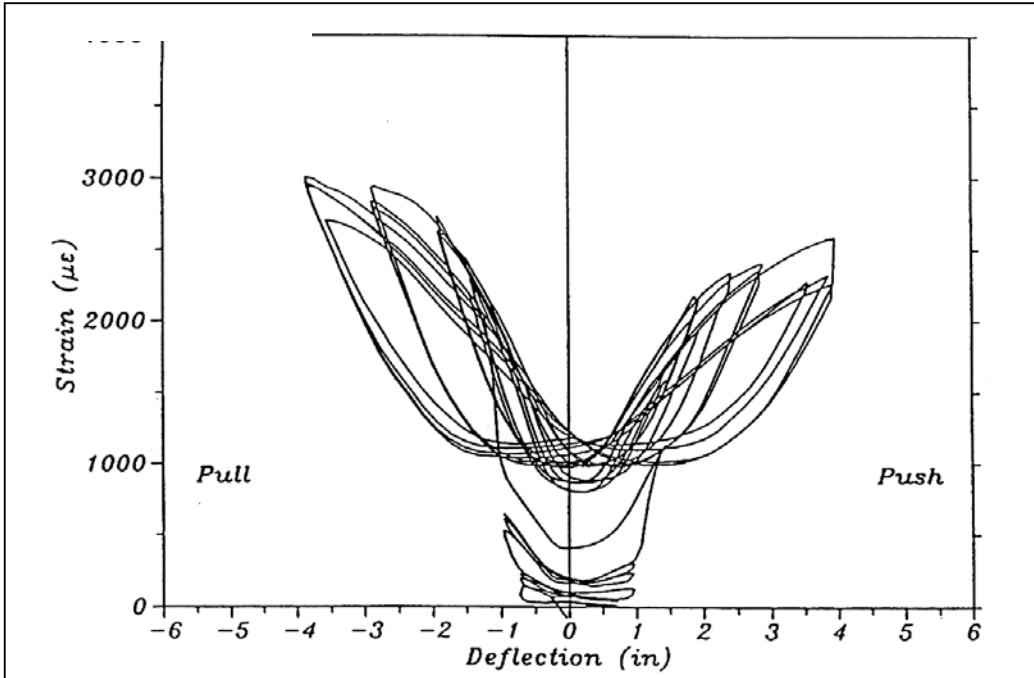
Figure B-5: Typical Strain-Deflection Plots for Rectangular Column RC03

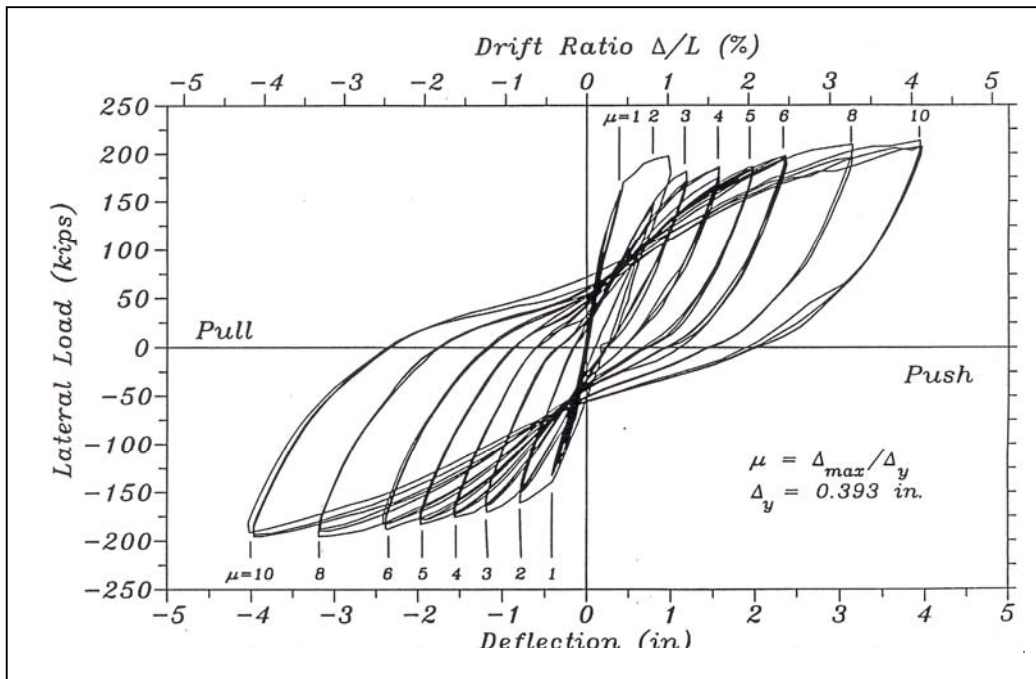
Figure D-2: Hysteresis Loop of Circular Column Retrofitted With Steel Jacket

Figure D-1 of Appendix D shows the force-deflection hysteresis behaviour of specimen without any retrofitting. The force-deflection hysteresis behaviour of the failed specimen retrofitted by steel jacket and FRP composite jacket are given in Figure D-2 and D-4. The test results indicated that the initial stiffness of the repaired test specimen was very similar to that of the original as-built column and the load-displacement response of the two columns was almost identical up to the displacement ductility $\mu_\Delta = 2.0$. Thus, the repair measure was effective in restoring the original column stiffness despite

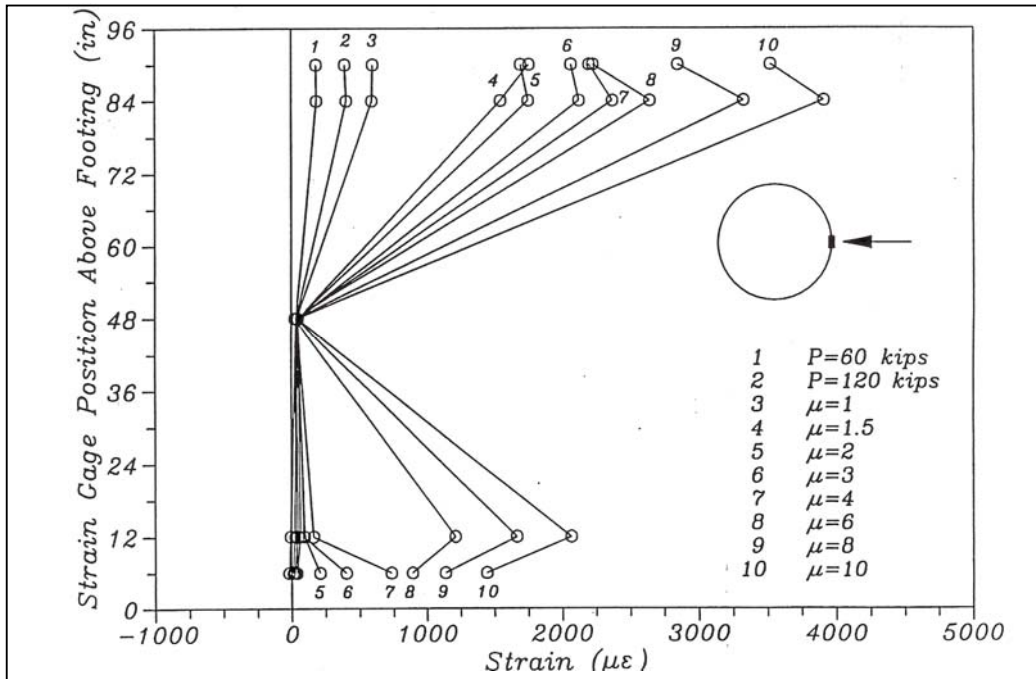
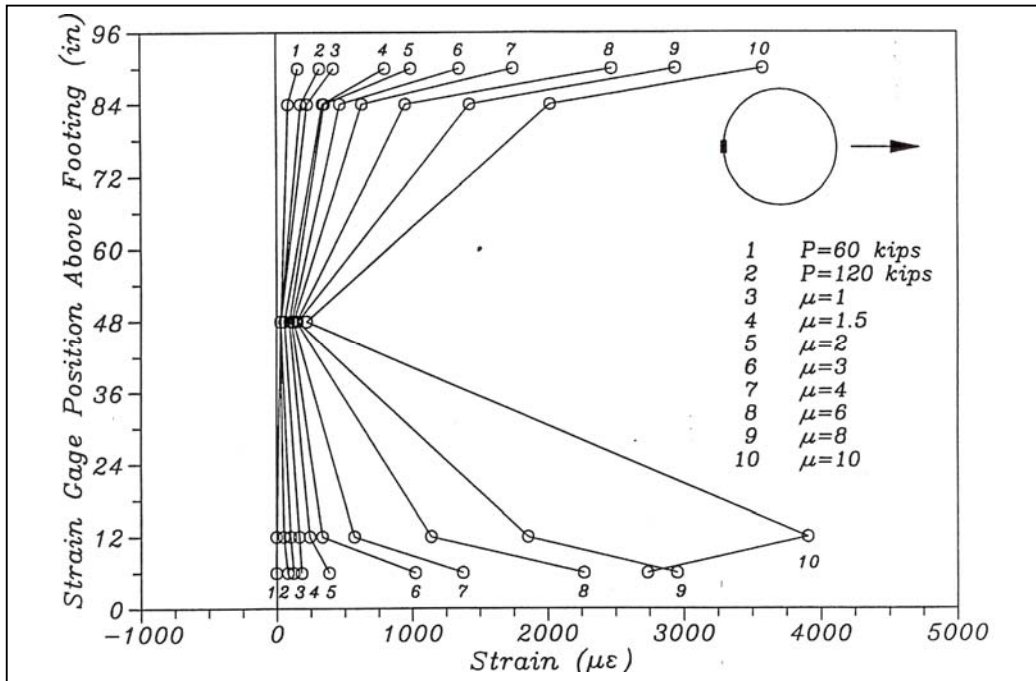
Figure D-6: Strain Profiles for Average of East and West Sides Push Direction

Figure D-7: Strain Profiles for Average of East and West Sides Pull Direction

Figure D-8: Strain Profiles for North Side Push Direction

Figure D-9: Strain Profiles for North Side Pull Direction

Figure D-10: Strain Profiles for South Side Push Direction

Figure D-11: Strain Profiles for South Side Pull Direction

The complete jacket strains response is provided in Figures D-6 to D-13. Vertical strain profiles depicted in Figures D-6 to D-11 show very low circumferential jacket strains in the mid-height region of the column, indicating the effectiveness of the epoxy injection of the inclined diagonal cracks in preventing cracks from reopening. High circumferential strains up to 0.004 were observed in the column end or plastic hinge regions. The circumferential strains along the column perimeter in the lower end region are depicted in Figures D-12 to D-13, and show a strain distribution along the jacket perimeter which does not indicate clear tendencies toward higher jacket strains along the sides or the generators in the loading direction. In Figure D-12, circumferential jacket strains seems to be concentrated at the compressed toe as a result of confinement requirements while the pull direction suggests a more even circumferential jacket strain distribution. Different damage patterns from the original shear column test can be a possible source for this un-symmetric behaviour.

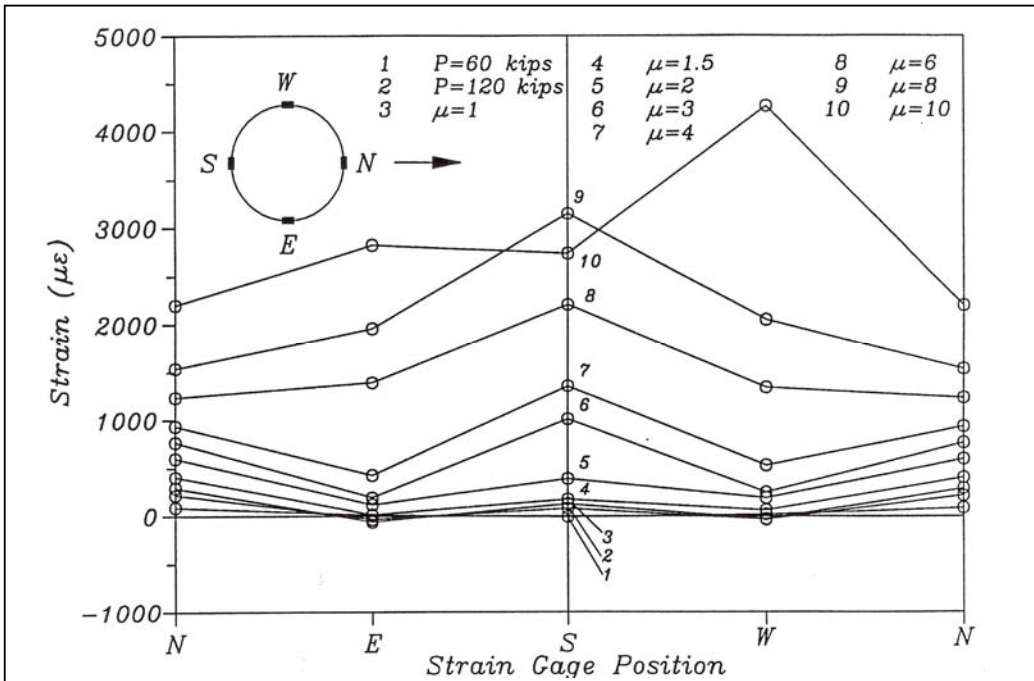
Figure D-12: Strain Profiles 6 Inches Up from Footing Push Direction

Figure D-13: Strain Profiles 6 Inches Up from Footing Pull Direction

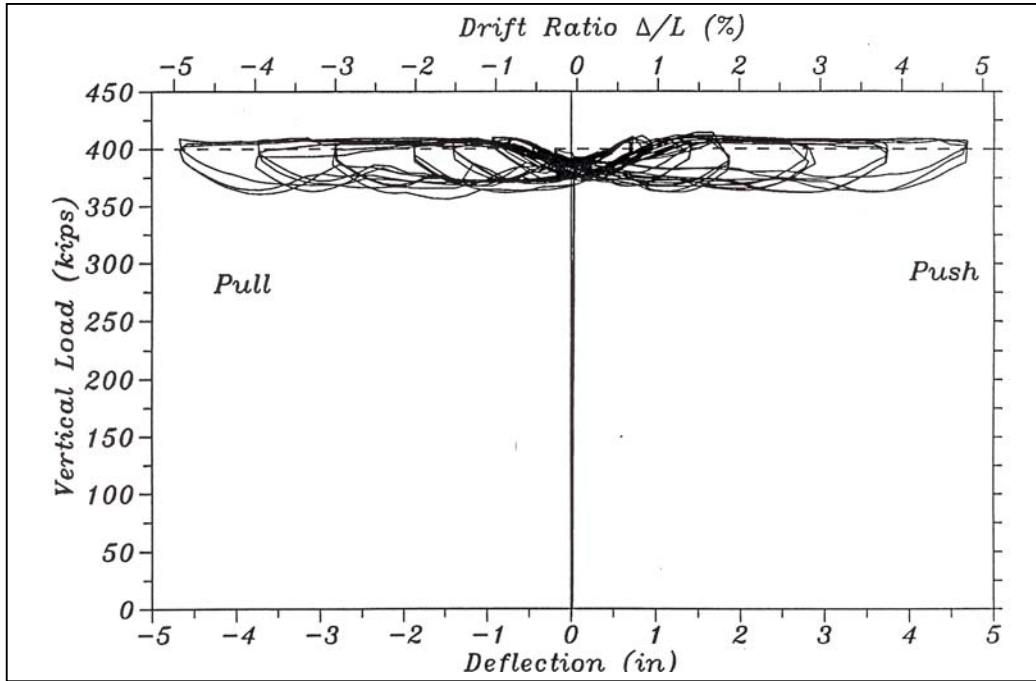
Figure D-14: Vertical Load vs Horizontal Deflection for Fibre Repaired Circular Shear Column
